Case Study : Ventilation Accident in a Pig Finishing Building

Animals	Finishing pigs, near finish weight
Number of animals	~900
Loss	35 + growth loss of remainder
Duration of ventilation loss	56 hours
Ventilation system	ACNV curtains with fans
Location	Midwest US
Cause of loss	Operator error

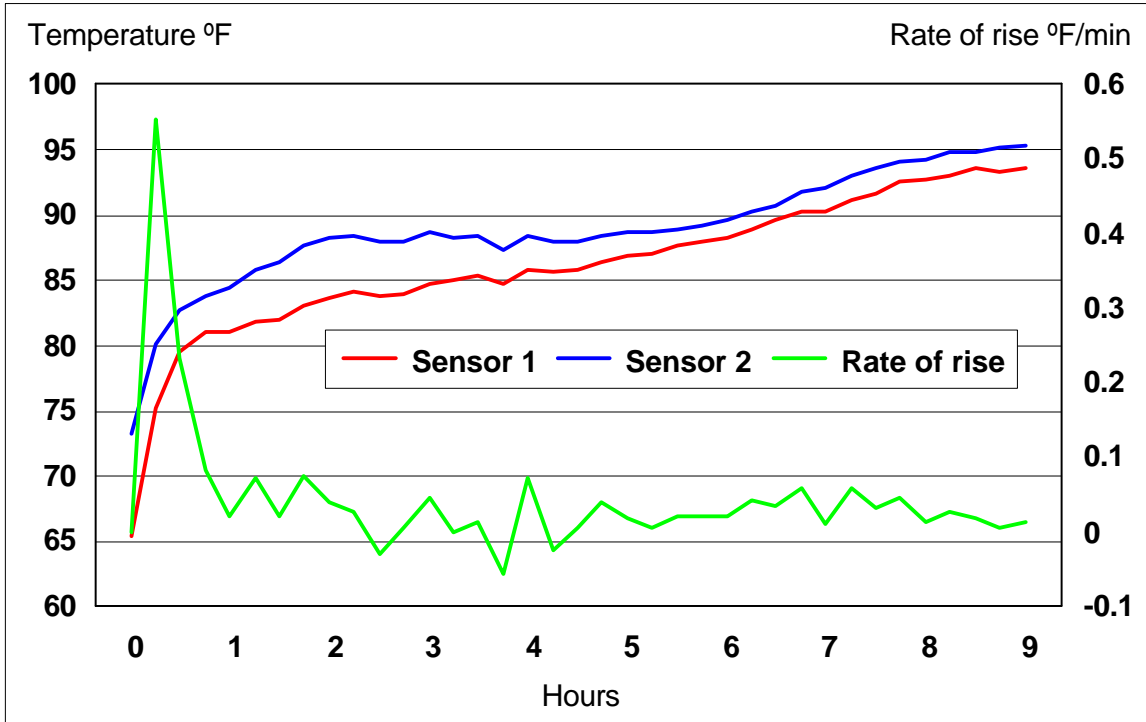
With no ventilation, temperatures rose. Left as it was, curtains were closed and unable to operate. Fans could be switched on by the controller, but with the settings as they were, would not switch on until room temperature reached about 98°F.

As in previously recorded incidents, the initial rate of temperature rise was high (over 0.5°F per minute), but this not sustained. Within an hour, the rate of rise fell to below 0.1°F per minute.

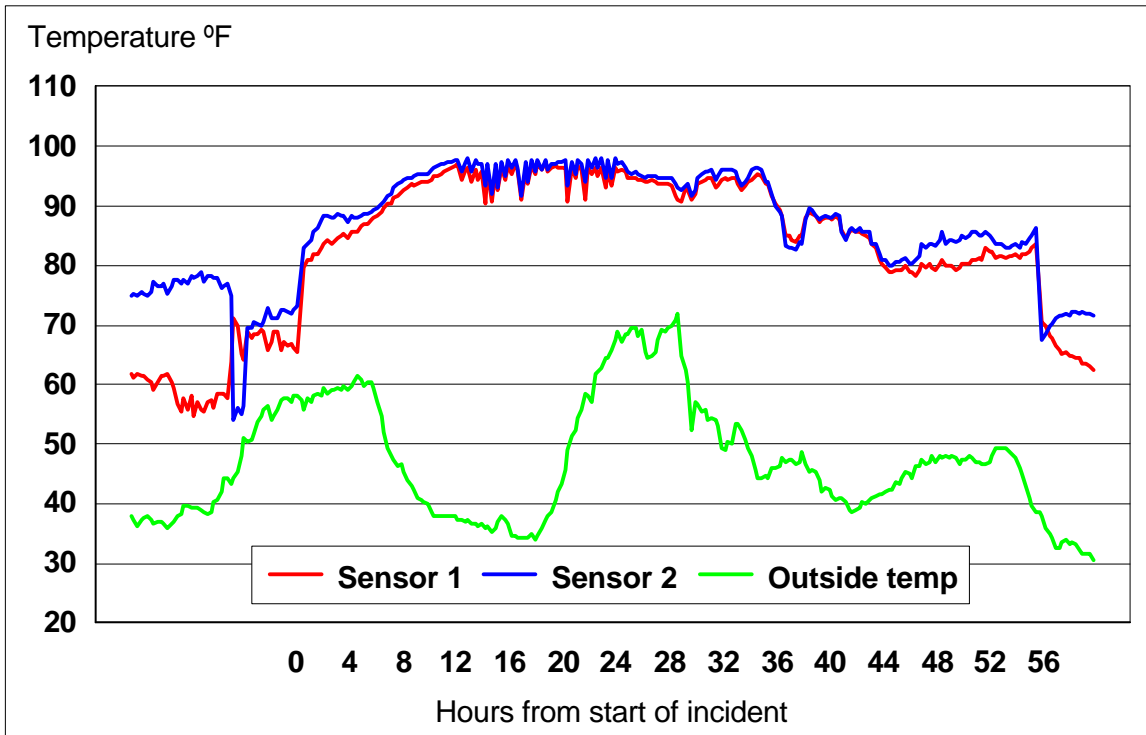
After about 12 hours, room temperature was high enough to cause fans to switch on. Due to a switching band, they would remain on only until (sensed average) room temperature dropped to about 94°F. This cycle (up to 98, down to 94°F) was repeated for around 12 hours or so.

Fan ventilation - albeit with limited capacity, and only dropping the room temperature marginally - may have alleviated pig suffering somewhat by relieving humidity, and may have contributed to the remarkably high survival rate from this incident.

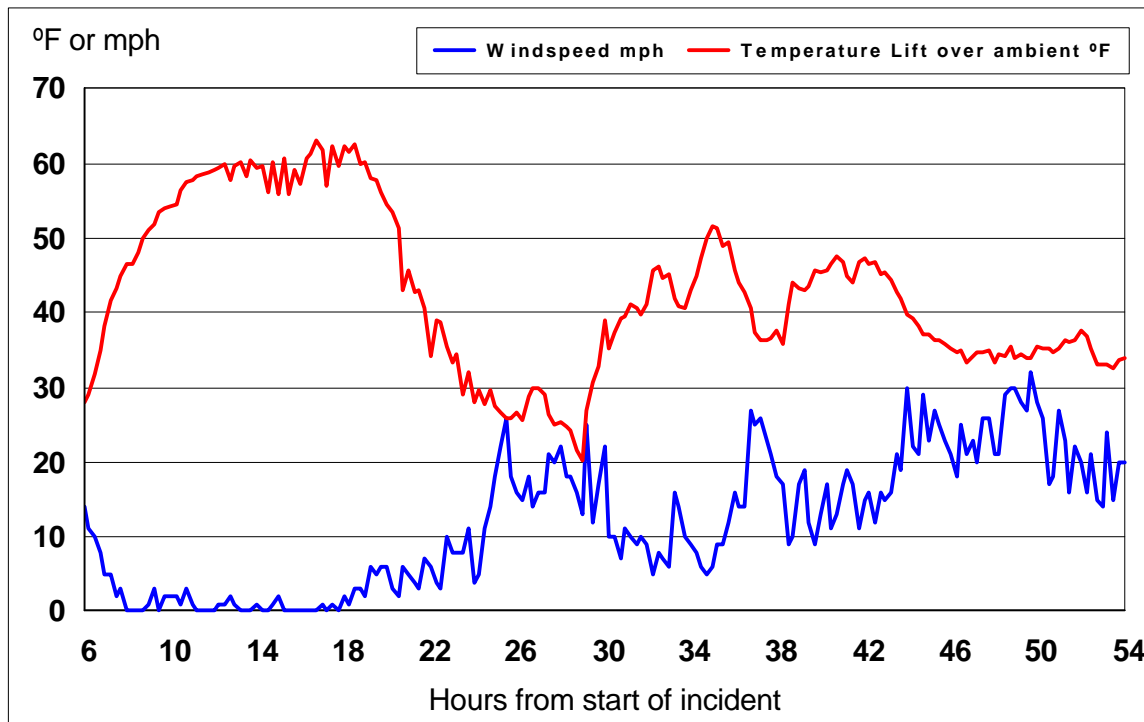
The situation was roughly stable, about 60°F hotter than ambient, for around 12 hours. Thereafter (about 24 hours or so into the incident), temperature began to fall. This appears to be due to a rise in wind speed - previously low.

This higher wind speed resulted in establishing a certain (low) ventilation rate, and it can be seen that temperature lift above ambient (indicative of ventilation rate) is inversely related to wind speed, though winds from different directions have varying effects.

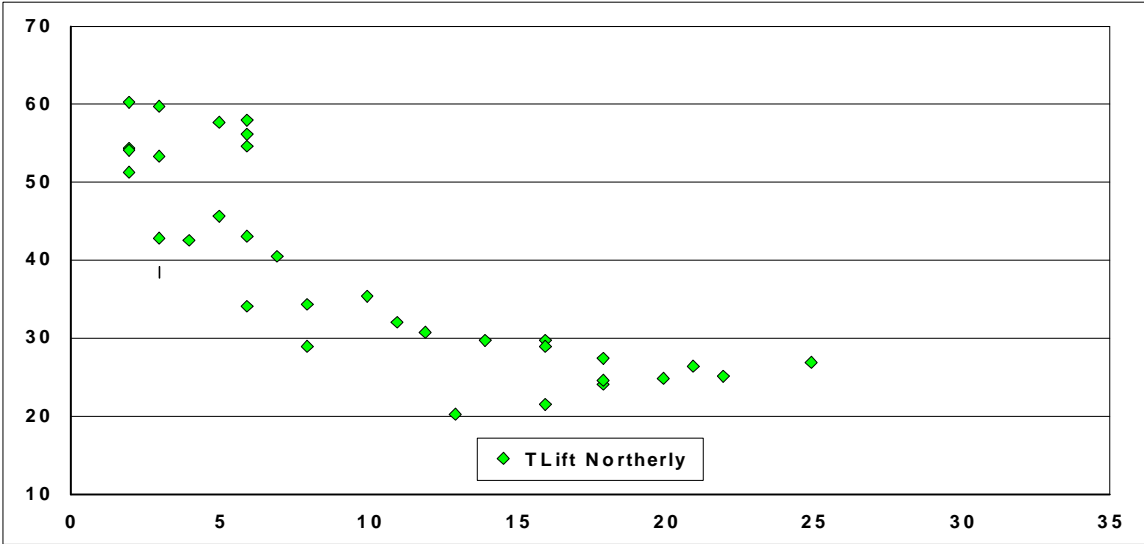
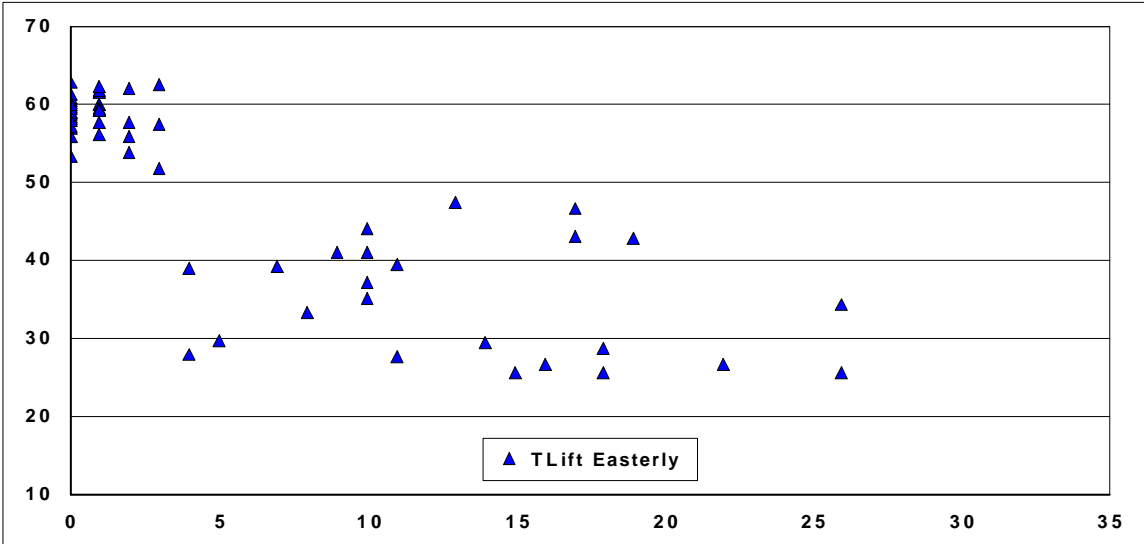
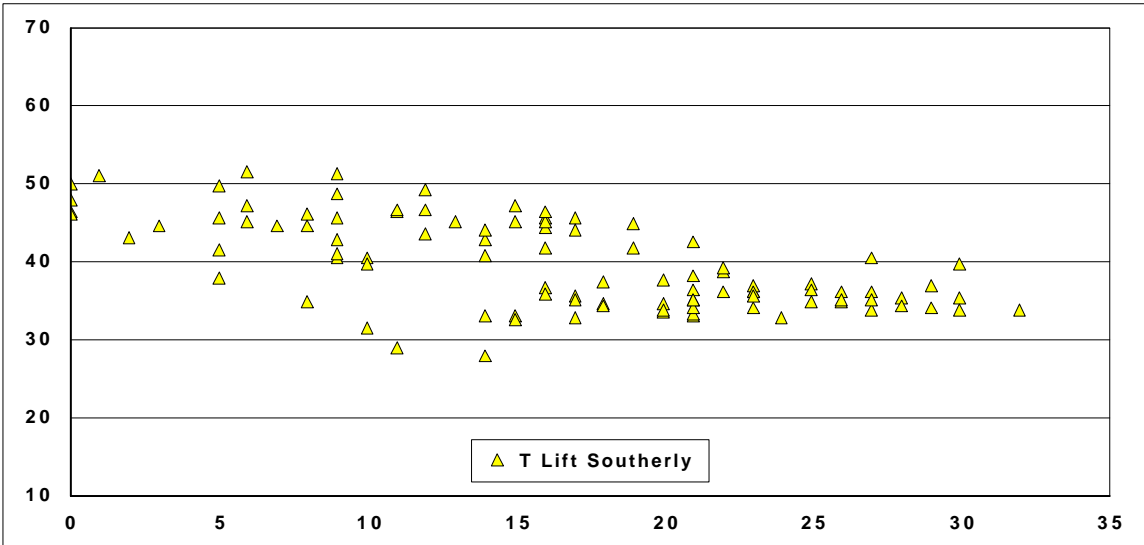
On the following page, wind direction has been roughly classified into North East or South (no winds recorded from the West), and the relation between temperature lift and wind speed indicated. During the incident, winds started mild and northerly, swinging around to the south and much stronger, before finally easing and veering to the north again.

It appears that the building is more exposed - or more sensitive - to winds from the North, as this has a greater effect in reducing temperature lift than other directions. For example, a 20 mph wind from the south gives around 38° temperature lift, whilst the same speed wind from the north results in only a 25° temperature lift.

However, ventilation in this way (relying as it does on small leaks in the building)) might be due to localised effects such as pressure differences and direction of apertures. (Also, it cannot be certain that the anemometer is correctly oriented.)
